GRADY-WHITE ENGINEERING TEST REPORT

ACRYLICO WINDSHIELD AND WIPER EVALUATION

Date: 2/7/11

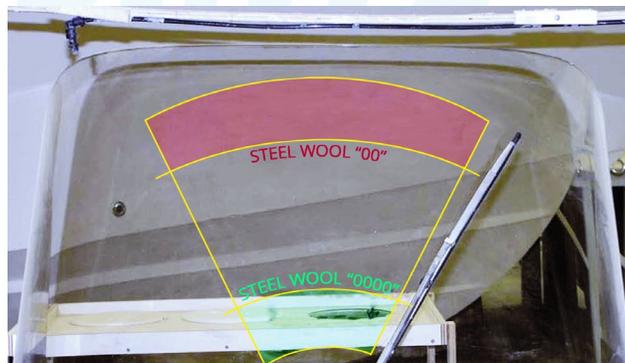
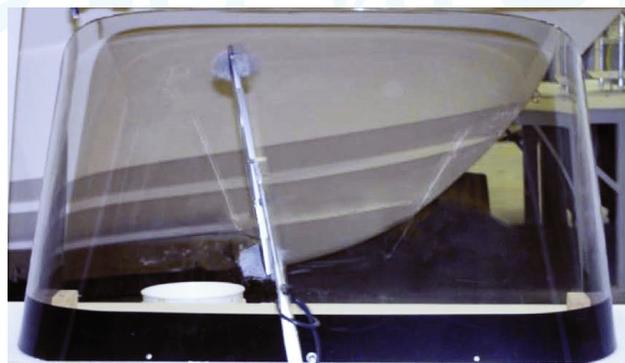
At the end of all tests, the windshield was completely free from any visible damage; a testament to AcryliCo's outstanding manufacturing standards and excellent hard coating finish.
