GRADY-WHITE ENGINEERING TEST REPORT

ACRYLICO WINDSHIELD AND WIPER EVALUATION

Date: 2/7/11

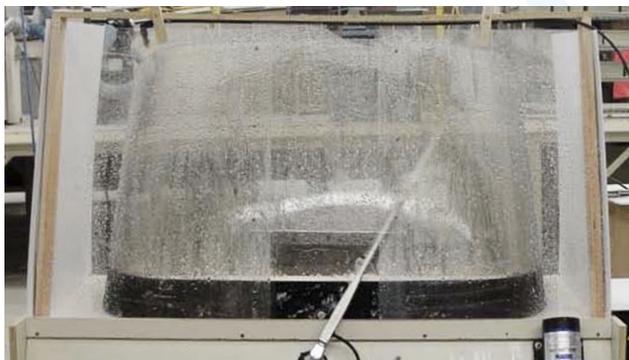
A platform was built to mount the windshield. Above the windshield a 1/4" tube with a series of small holes was placed to irrigate the windshield via a low volume diaphragm pump. This provided a constant spray of water onto the windshield when desired. A wiper motor was mounted below the windshield, at a similar height and angle as for wiper motors on production boats. Therefore, the pressure of the wiper arm against the windshield would have been comparable to current technical configurations.

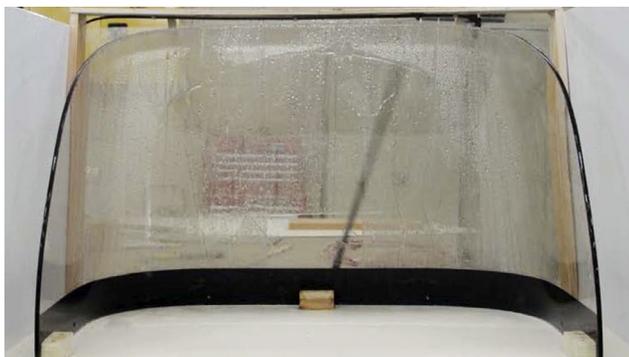
The endurance test was performed over a period of 100 hours, estimated at 330,000 wiper cycles.

At the end of all tests, the windshield was completely free from any visible damage; a testament to AcryliCo's outstanding manufacturing standards and excellent hard coating finish.
